Green Lake
Green Lake County, Wisconsin
Aquatic Plant Management Plan
April 2025

Official First Draft
Soliciting Agency & Public Comments

Created by: Eddie Heath, Todd Hanke, and Tim Hoyman
Onterra, LLC
De Pere, WI

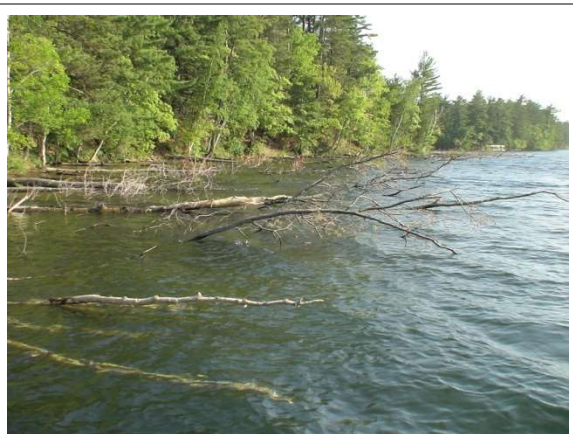
Photograph 3.1-1. Example of coarse woody habitat in a lake.

Coarse woody habitat has shown to be advantageous for fisheries in terms of providing refuge, foraging area, as well as spawning habitat (Hanchin et al. 2003). In one study, researchers observed 16 different species occupying coarse woody habitat areas in a Wisconsin lake (Newbrey et al. 2005). Bluegill and bass species in particular are attracted to this habitat type; largemouth bass stalk bluegill in these areas while the bluegill hide amongst the debris and often feed upon many macroinvertebrates found in these areas, who themselves are feeding upon algae and periphyton growing on the wood surface. (Newbrey et al. 2005) found that some fish species prefer different complexity of branching on coarse woody habitat, though in general some degree of branching is preferred over coarse woody habitat that has no branching.

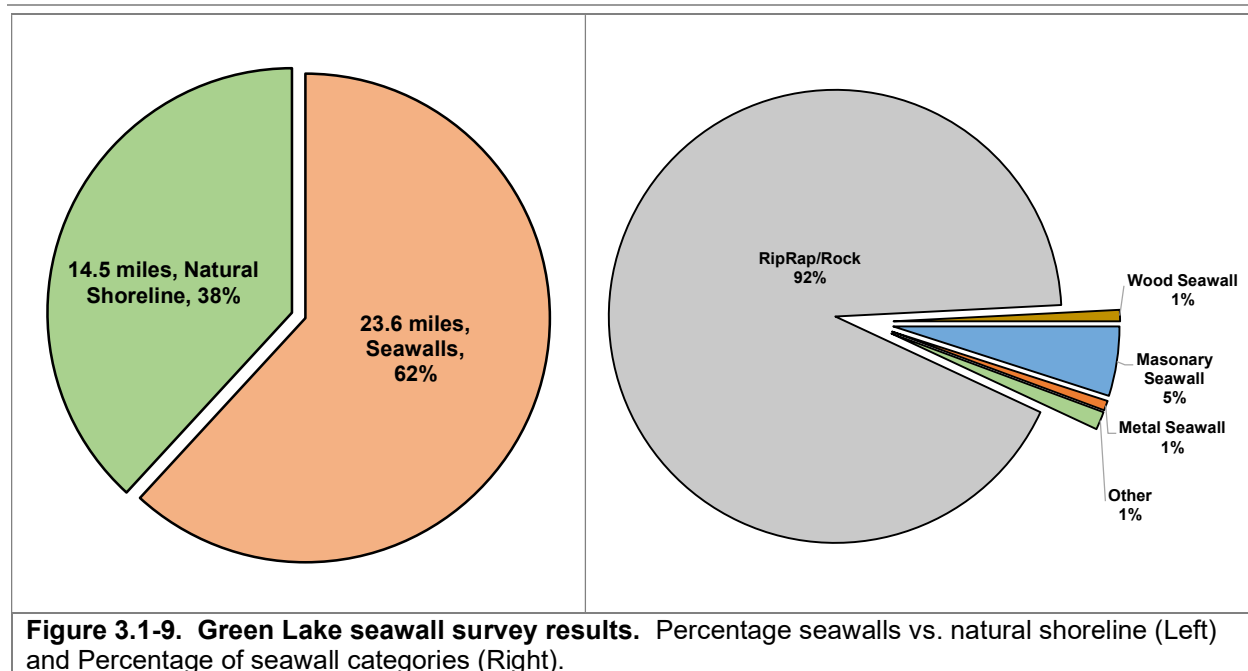
The Green Lake PMT sponsored a supplemental survey of the Green Lake system's shoreline, to determine the extent and type of seawalls on the lake. Seawalls were delineated with submeter accuracy and classified in five different categories (masonry, metal, riprap/rock, wood, or other). Seawalls are commonly installed to protect the shoreline from erosion due to large wave action. During this survey, 23.6 total miles of seawall were observed along 40.4 miles of shoreline (Map 6). Most of the seawall was classified as riprap/rock, followed by masonry, and other (Figure 3.1-9).

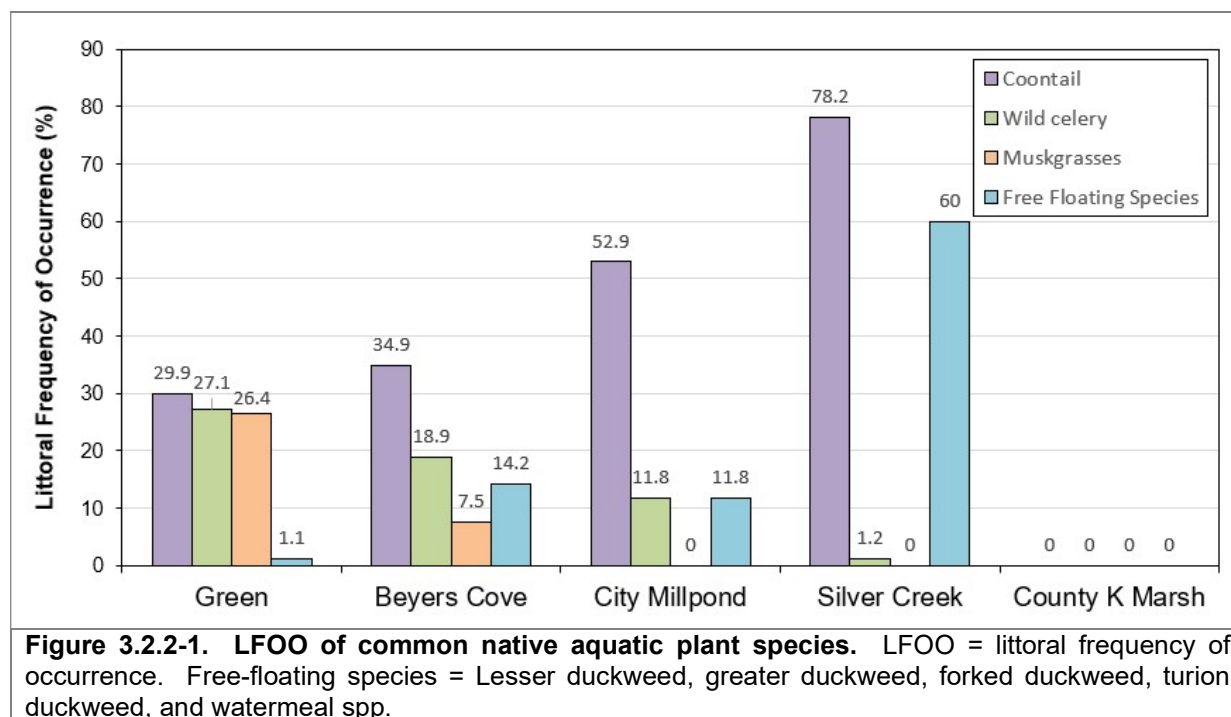
The most common plant species in the Green Lake system is coontail (Figure 3.2.2-1). Coontail has whorls of leaves which fork into two to three segments, providing lots of surface area for the growth of periphyton and habitat for invertebrates. Unlike most of the submersed plants found in Wisconsin, coontail does not produce true roots and is often found growing entangled amongst other aquatic plants or matted at the surface. Since it lacks true roots, coontail derives most of its nutrients directly from the water (Gross et al. 2003). This ability in combination with a tolerance for low-light conditions allows coontail to become more abundant in eutrophic waterbodies with higher nutrients and low water clarity. Coontail has the capacity to form dense beds that can float and mat on the water's surface.

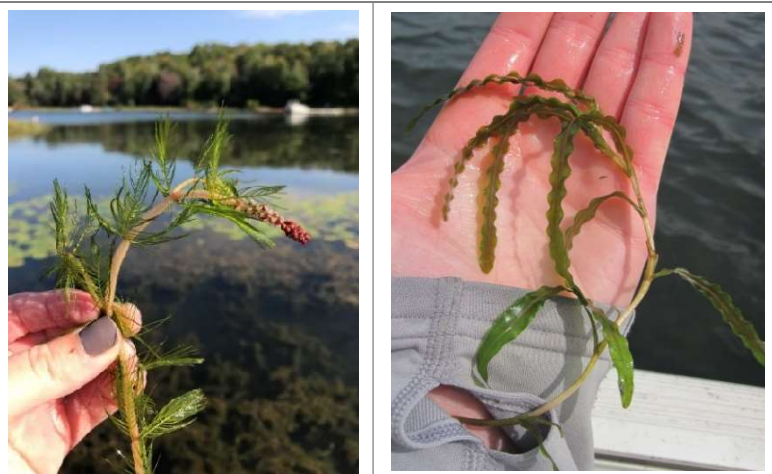
Photograph 3.2.2-3. Eurasian watermilfoil (left) and curly-leaf pondweed (right) from Green Lake. Photo credit Onterra.

The Green Lake system is known to harbor two non-native submersed aquatic plant species, Eurasian watermilfoil (EWM) and curly-leaf pondweed (CLP) (Photography 3.2.2-3). Both of these plant species are native to Europe and Asia and can thrive in some Wisconsin waterways to levels that can impact navigation and recreation as well as alter the way the ecosystem functions. In some lakes, these species can integrate into the overall aquatic plant community and only provide minor negative attributes.

EWM was first documented in Green Lake in 1969. In 2010, DNA analysis revealed that the plants in Green Lake were hybrid water milfoil (HWM), a cross between EWM and the indigenous northern water milfoil. Onterra ecologists sent in additional milfoil samples in 2013, and these were also confirmed as HWM. HWM can grow faster, become more invasive, and be less susceptible to chemical control strategies than pure-strain EWM. Unless specifically indicated, this report will use the term “EWM” to refer to the combined population of EWM and HWM within Green Lake.

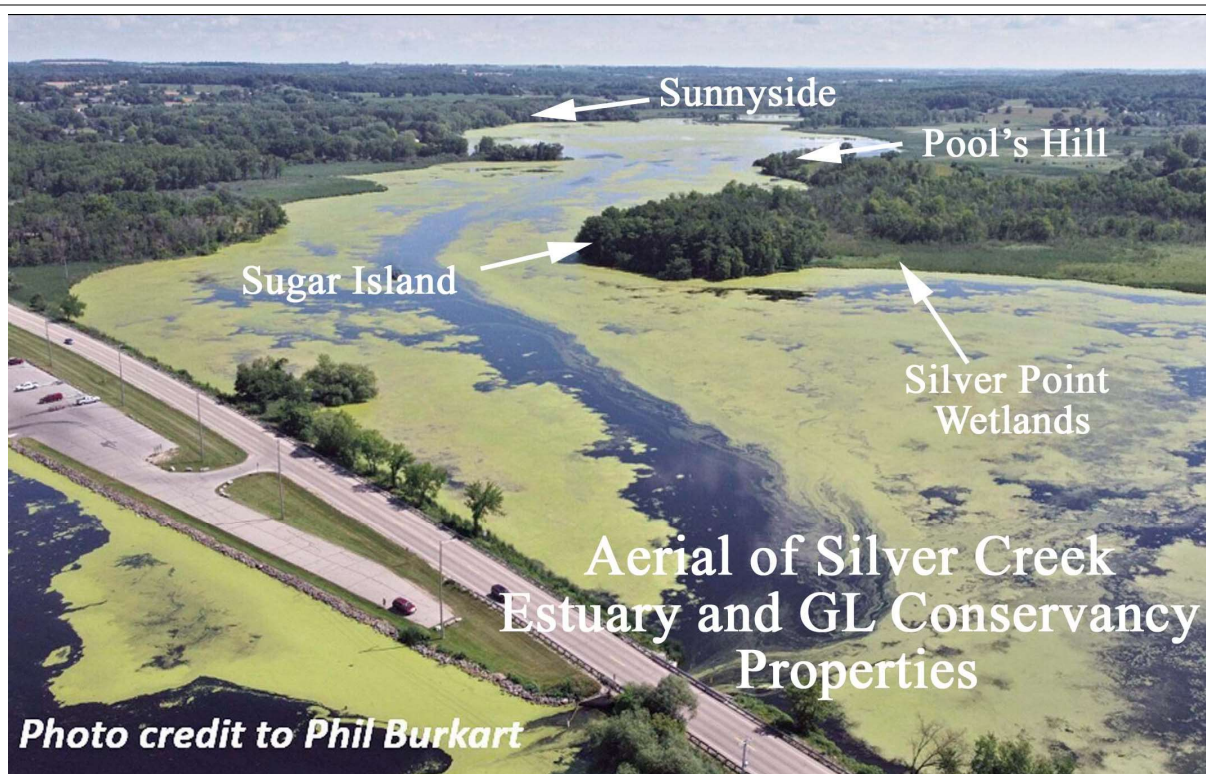
Photograph 3.2.2-5. Duckweed in Silver Creek Estuary. Photograph credit Phil Burkart.

The free-floating plants are made up largely of lesser duckweed (*Lemna minor*), turion duckweed (*Lemna turionifera*) and watermeal species (*Wolffia* spp.); with lesser amounts of forked duckweed (*Lemna trisulca*) and greater duckweed (*Spirodela polyrhiza*). These species can vary in abundance at any given time and are influenced by flow or wind driven water movement since they are not rooted in the sediment. Reliable anecdotal reports indicate sizeable duckweed populations originating in Silver Creek started appearing after the carp management program was initiated. An official plant survey conducted in 2007 documented a high population of duckweed in Silver Creek. Photograph 3.2.2-5 shows the current condition of Silver Creek as it relates to duckweed coverage.

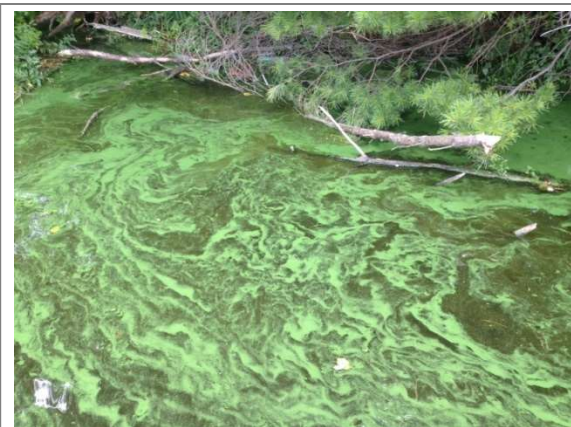
Photograph 3.2.2-7. Blue-green algae bloom on a Wisconsin lake. Photo credit: Onterra.

Like ‘true’ algae, cyanobacteria or blue-green algae are able to convert sunlight into energy through the process of photosynthesis (Photograph 3.2.2-7). Many species of blue-green algae can naturally be found in Wisconsin waters, some of which can produce toxins potentially dangerous to people and animals. Exposure to these toxins can be from ingestion of water, skin contact, or by inhaling aerosolized water droplets.

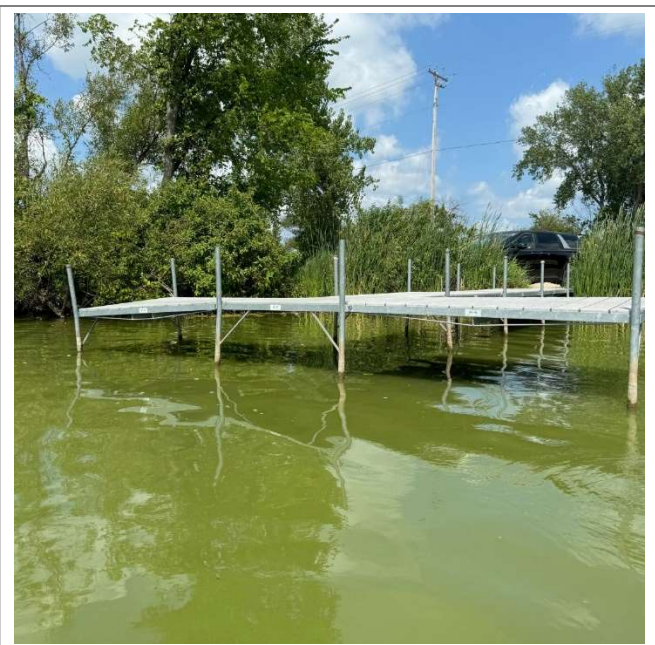
Photograph 3.2.2-8. 2024 BGA Bloom on County K Marsh. Photo credit: GLA 7/31/2024.

On August 1, 2024, confirmed BGA blooms positive for microcystin toxins resulted in closure of select beaches by the Green Lake County Health Department (Photograph 3.2.2-8). All advisories and closures were lifted within 6 days.

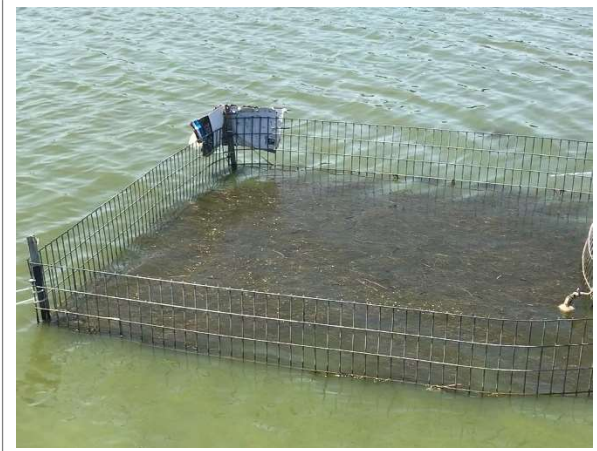
Photograph 3.2.7-1. Sago pondweed in carp enclosure from County K Marsh. Photograph credit Onterra, 7/3/2018

The GLSD has made attempts to understand the factors limiting vegetation growth in County K Marsh. Water celery and sago pondweed were planted within fenced carp enclosures in this system. While the vegetation grew prolifically during the summer, especially sago pondweed (Photograph 3.2.7-1), these plants did not survive the winter and did not regrow the following year.
